# Old-House Journal's NEW OLD HOUSE

Architect Sandy Vitzthum joins old and new blissfully in the restoration and renovation of a Vermont farmhouse.

# Vermont Farmhouse

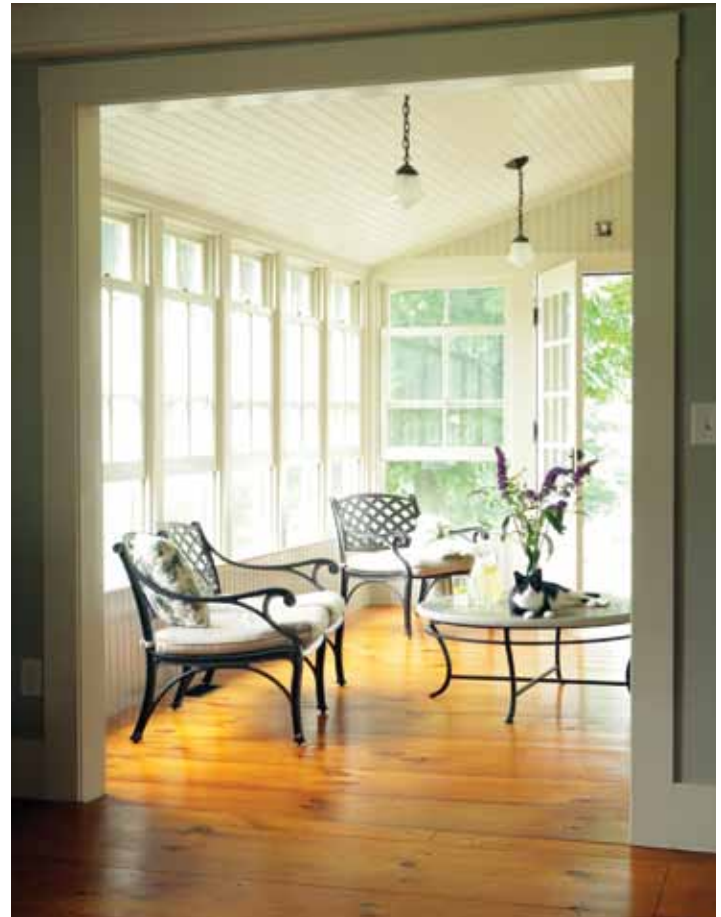
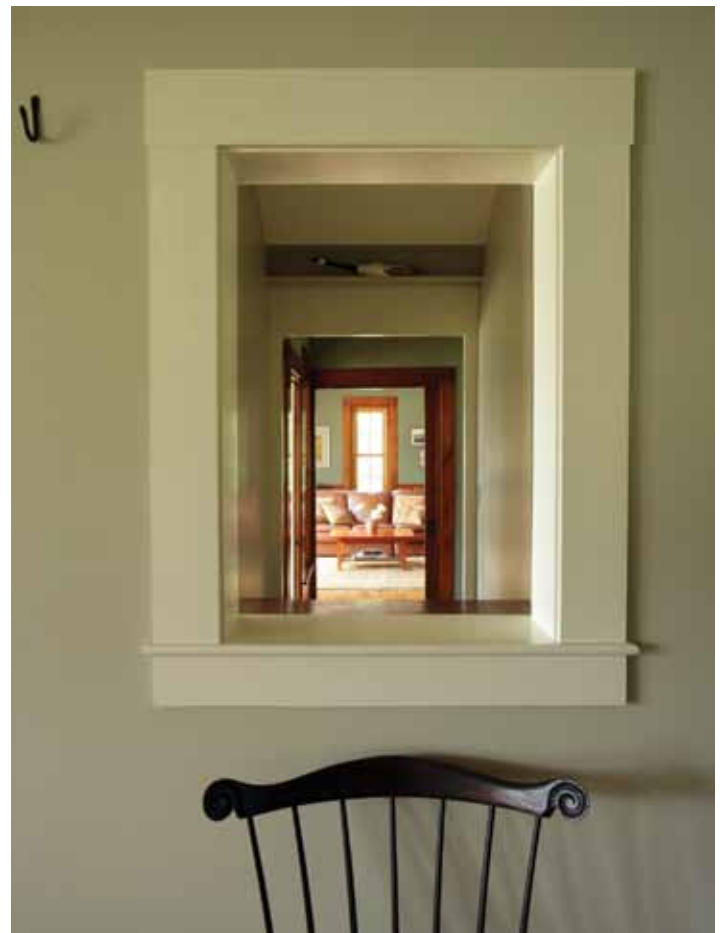
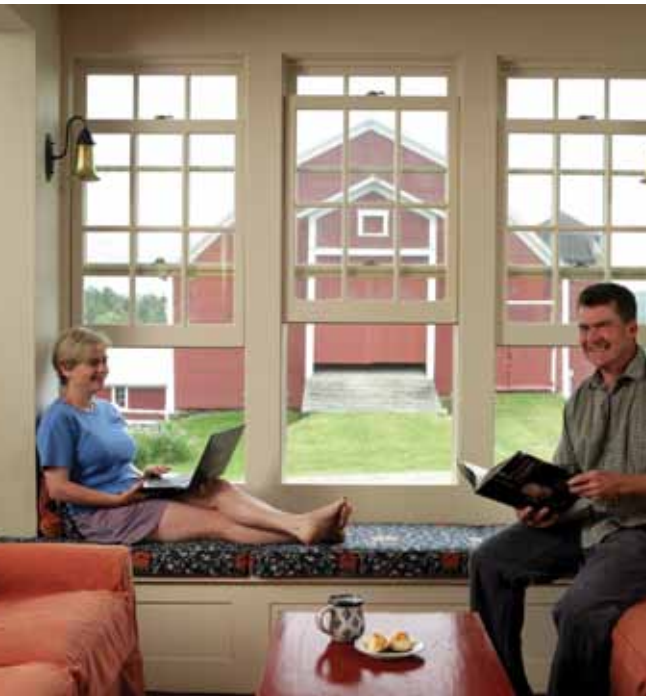
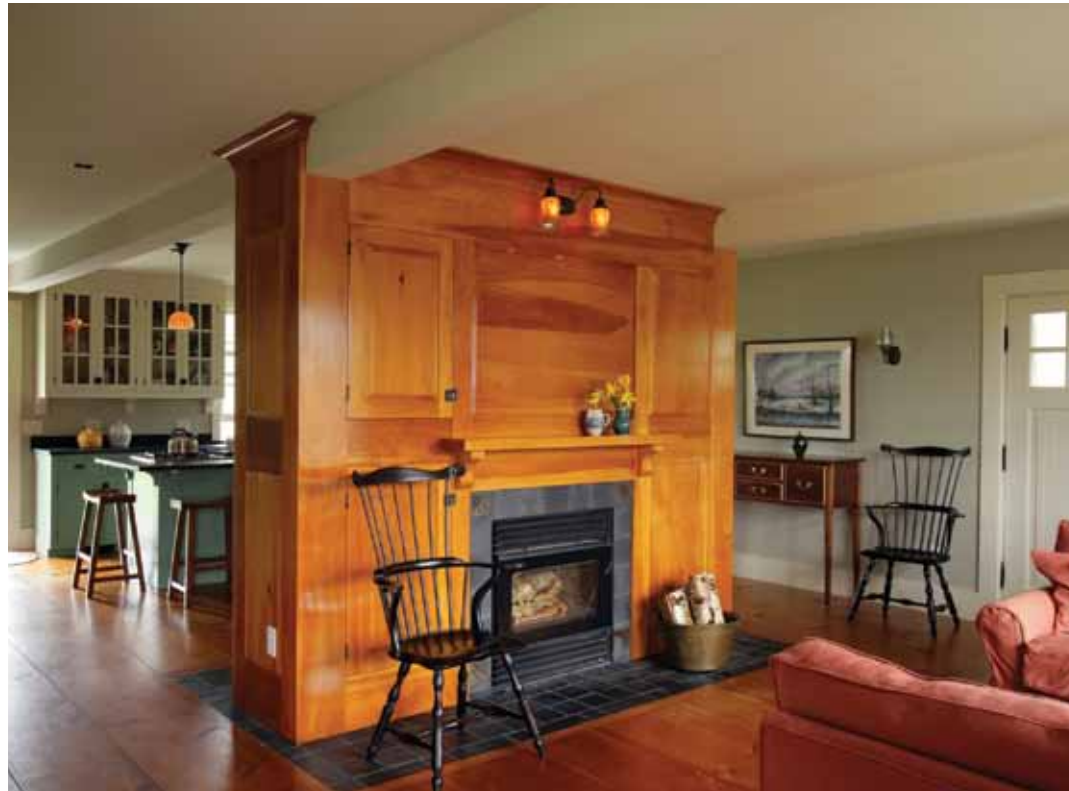
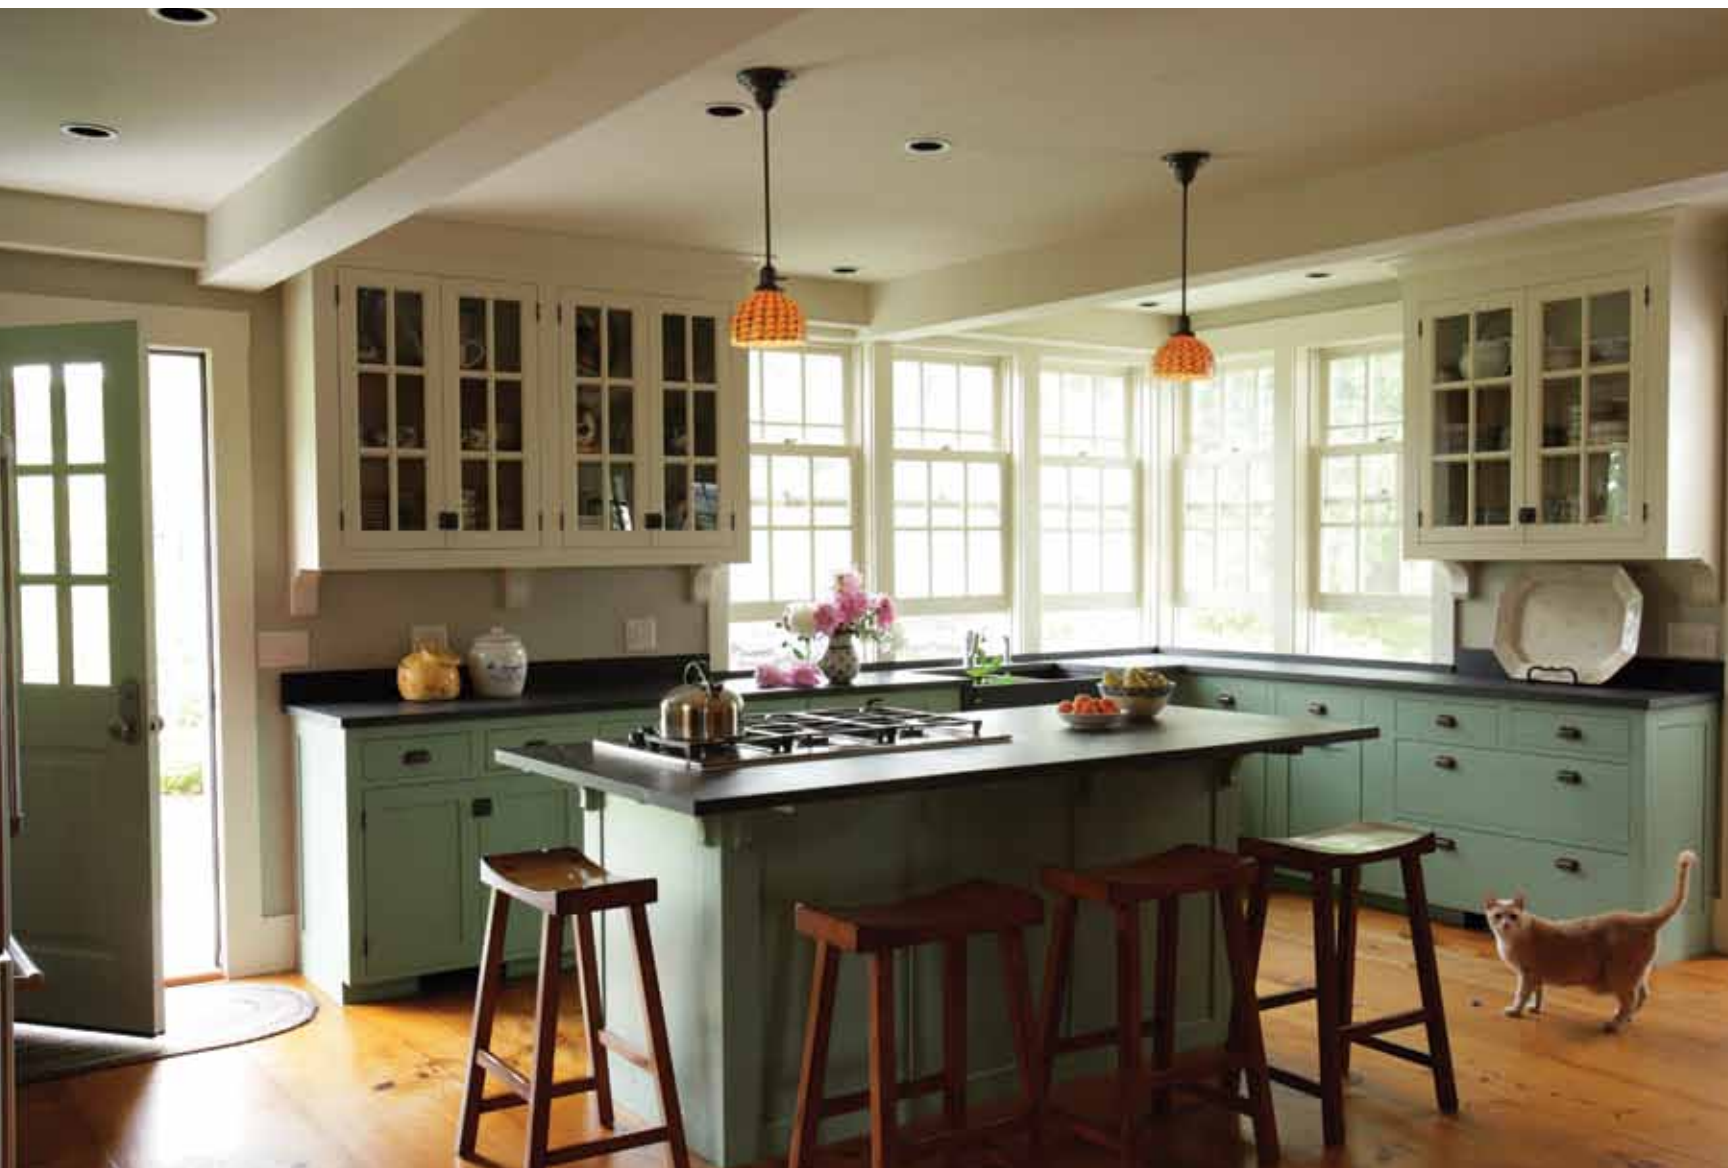
Opposite page: Vitzthum reconfigured the staircase. A new entryway was added to the far end of the house. This page top: A beadboard ceiling was added to the glassed-in porch. A small window offers a sight line into the older section of the house.

porch's ceiling was taken down and refinished with a new beadboard ceiling, and unappealing metal casement windows were replaced with double-hung windows that look toward the original dairy barn. She also reconfigured the staircase, adding a bottom leg run. A small window above the landing offers views from the sunporch into the kitchen and beyond to a stone folly on the hill. "Whenever sight lines can be extended through multiple rooms, it makes the rooms feel larger," says Vitzthum.

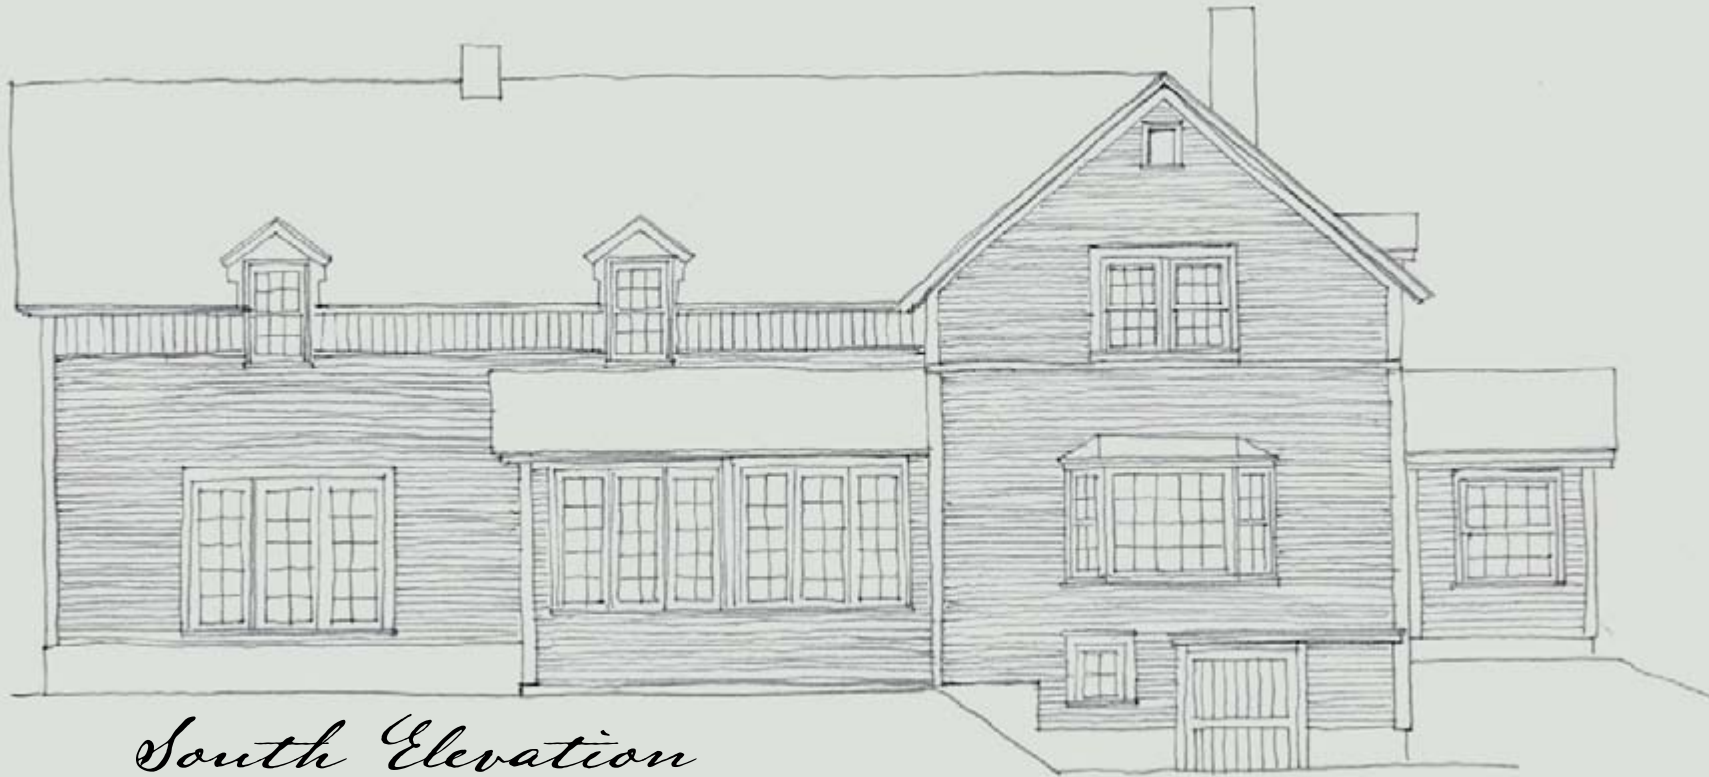
South Elevation

says. “It was an old post-and-beam frame, so we had to work around these structural supports.” One major change to the carriage barn was the roof. “Originally it had an unattractive hipped roof,” explains Vitzthum, “so I took some liberties and created a true gabled structure.” Another liberty Vitzthum took in the design was to create large window openings. “The original carriage barn would have had no windows at all,” she says, “but we added double-hung windows to take in the views of the fields and hills surrounding the house.”

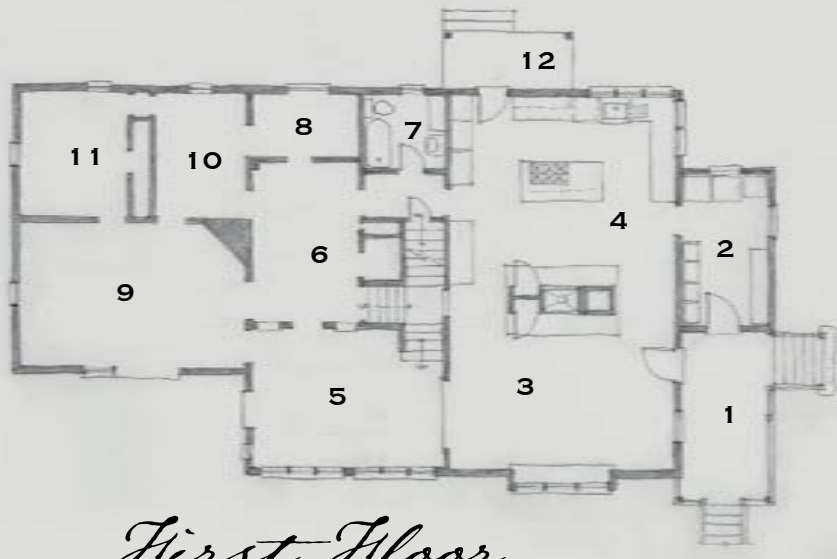
First Floor

| 1 PORCH | 6 DINING ROOM |
| 2 MUD ROOM | 7 BATHROOM |
| 3 FAMILY ROOM | 8 PANTRY |
| 4 KITCHEN | 9 LIVING ROOM |
| 5 GLASSED IN PORCH | 10 SPINNING ROOM |
| | 11 GUEST ROOM |

The new kitchen and family room are in one space divided in the center by a freestanding wood-burning fireplace and mantel. “This design was really chosen out of necessity,” says Vitzthum. “There was a flue in the middle of the room that we could not move, so the fireplace became a way to divide the two areas without completely separating them.” Cabinetmaker Ron Walesch built the mantel with 24-inch salvaged pine panels, stained in amber shellac to harmonize with the butternut paneling in the older section of the house. The wall surfaces are continuous in this space—when looking from one room to the other, you feel as if they are tied together.

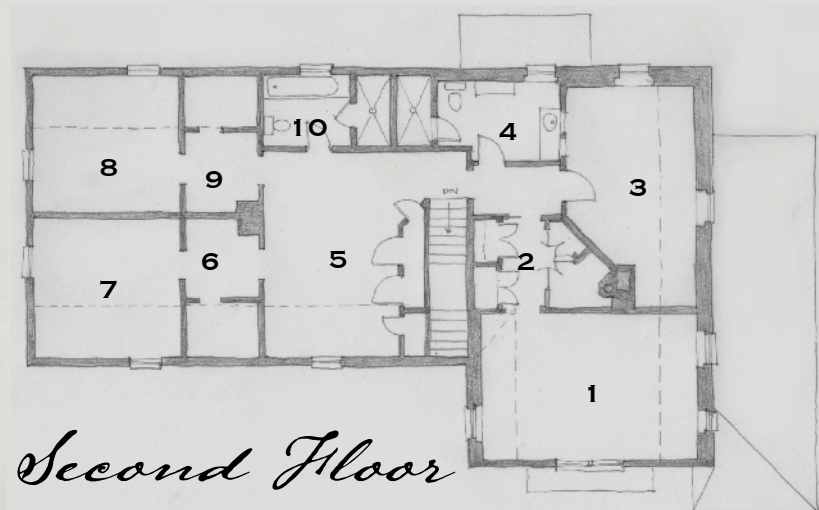
Second Floor

| 1 MASTER BEDROOM | 8 BEDROOM |
| 2 CLOSET | 9 ENTRY/ CLOSET |
| 3 OFFICE | 10 BATHROOM |
| 4 BATHROOM | |
| 5 SITTING ROOM | |
| 6 ENTRY/CLOSET | |
| 7 BEDROOM | |
